## Shinyanga OR19-9 Test Site – Atmospheric Corrosivity

### Site OR19-9

Installation: 13-12-2019

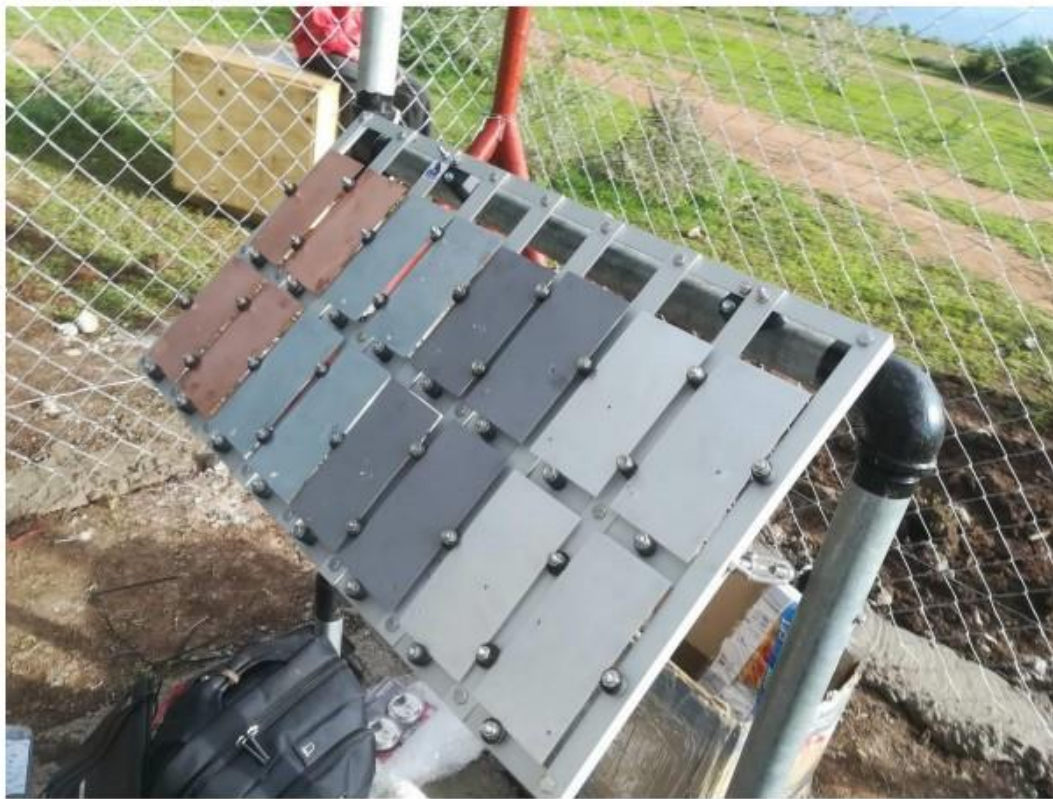
Shinyanga Test Site (Image by Geosun).
