Homa Bay OR19-16 Test Site – Atmospheric Corrosivity

Site OR19-16

Installation: 07-12-2019

ISO 9226 Corrosion Rates and ISO 9223 Corrosivity Classification

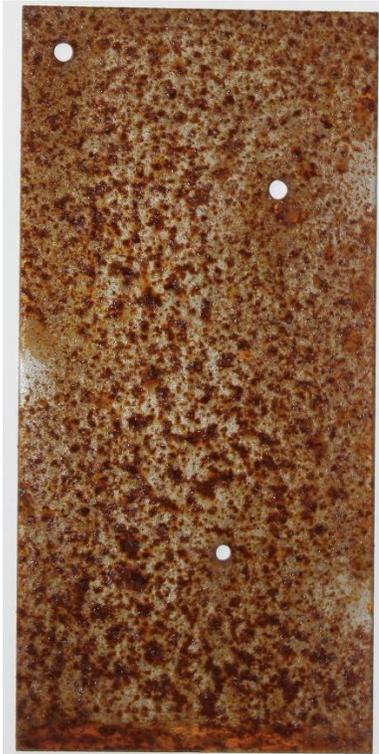
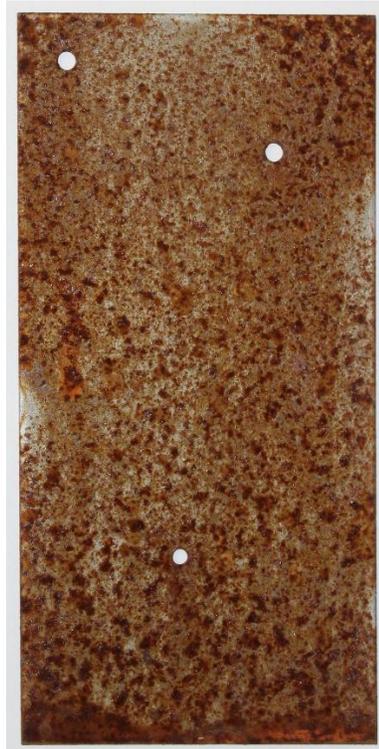
12-month R_{CORR} Mild steel (µm/yr)	3.5 ± 0.2 µm/yr
12-month R_{CORR} Aluminium (µm/yr)	<0.1 µm/yr (Negligible)
12-month R_{CORR} Hot Dip Galvanised Steel (µm/yr)	0.6 ± 0.05 µm/yr
12-month R_{CORR} Copper (µm/yr)	0.8 ± 0.05 µm/yr
ISO 9223 Corrosivity Classification	Low (C2)
Typical surface contaminants	<testing still in progress>

Mild steel – 12 months

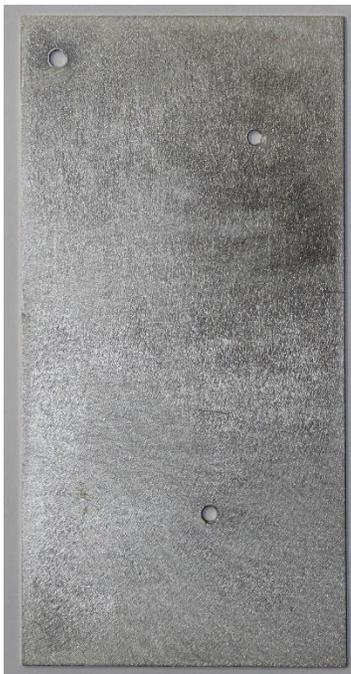
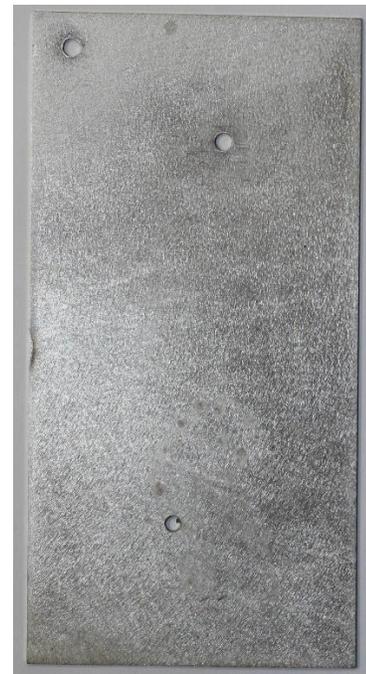
Aluminium – 12 months

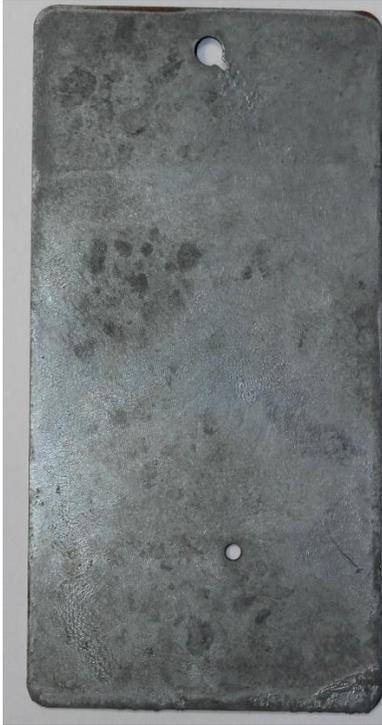
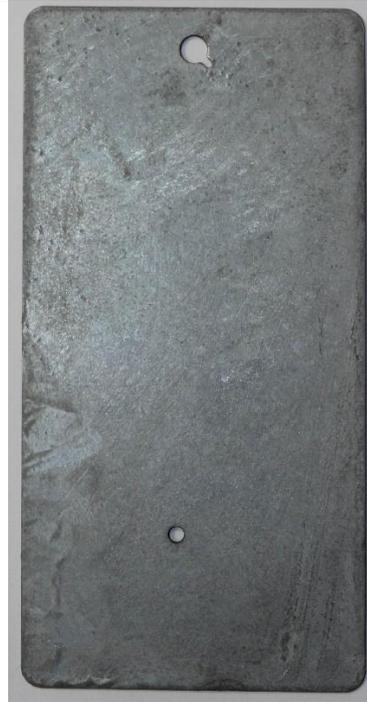
HDG – 12 months

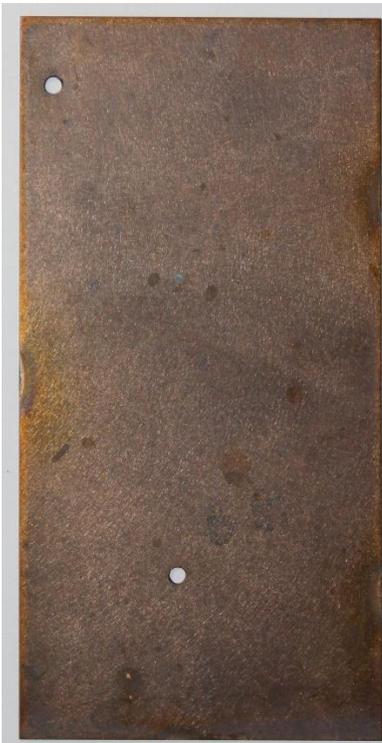
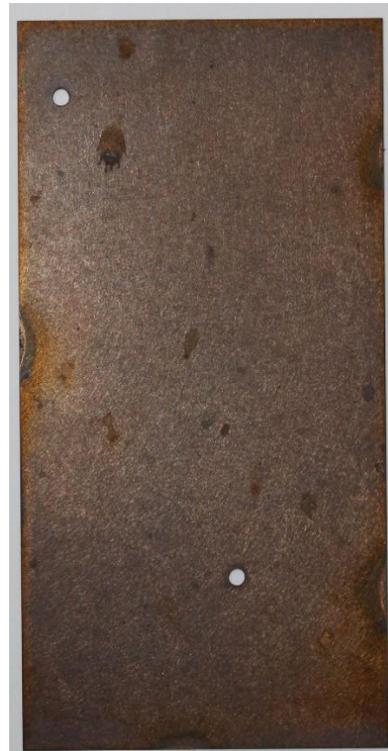
Copper – 12 months
