## Shinyanga OR19-9 Test Site – Atmospheric Corrosivity

### Site OR19-9

Installation: 13-12-2019

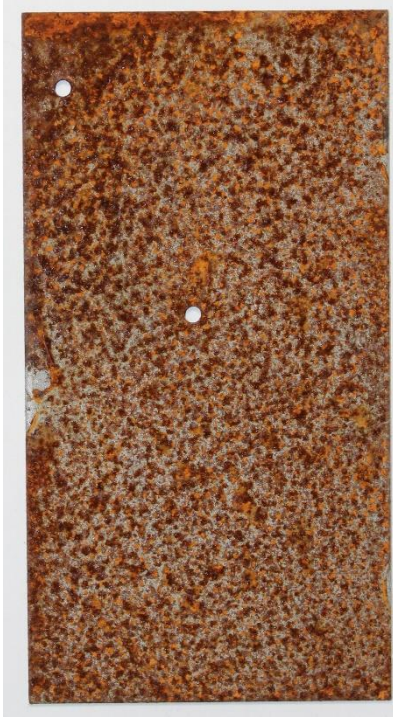
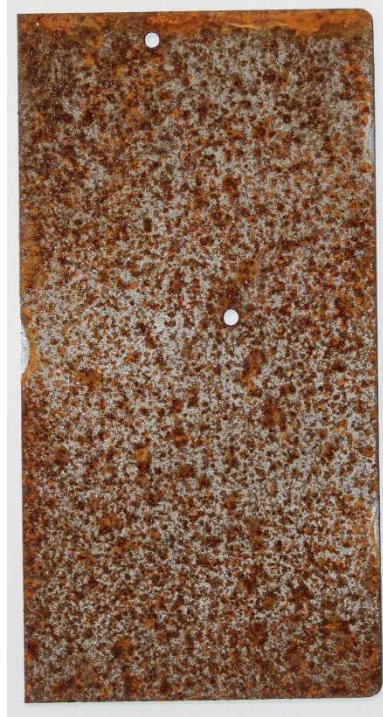
**Mild steel – 12 months**

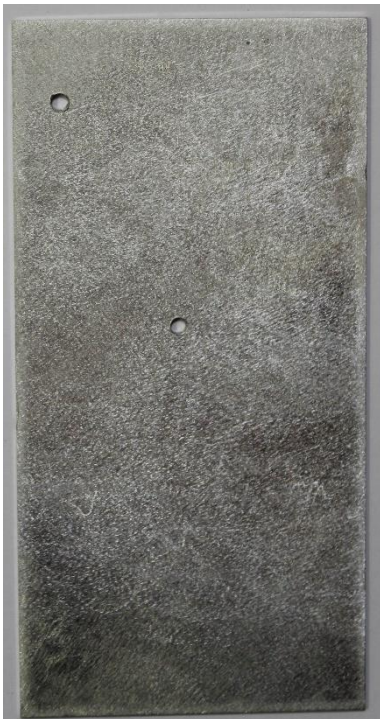
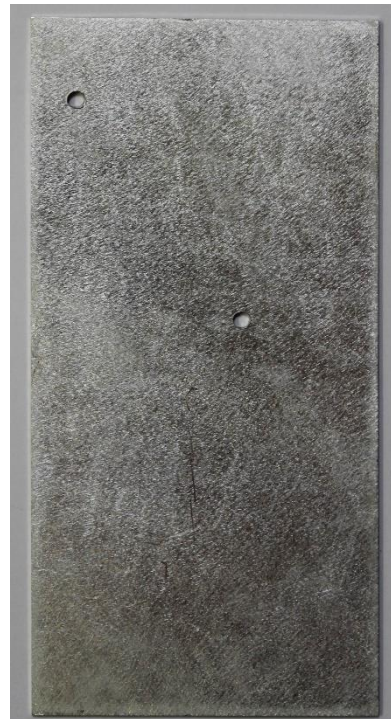
**Aluminium – 12 months**

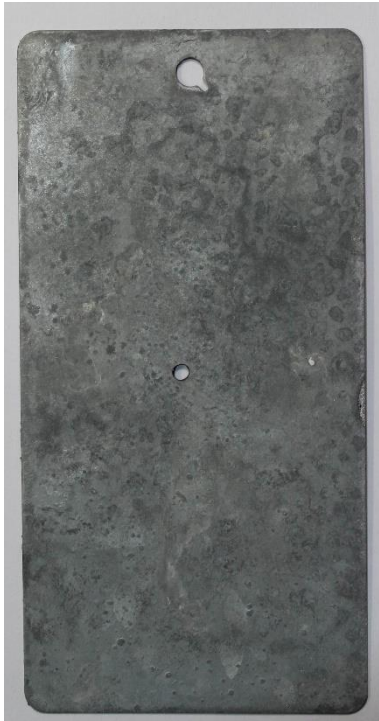
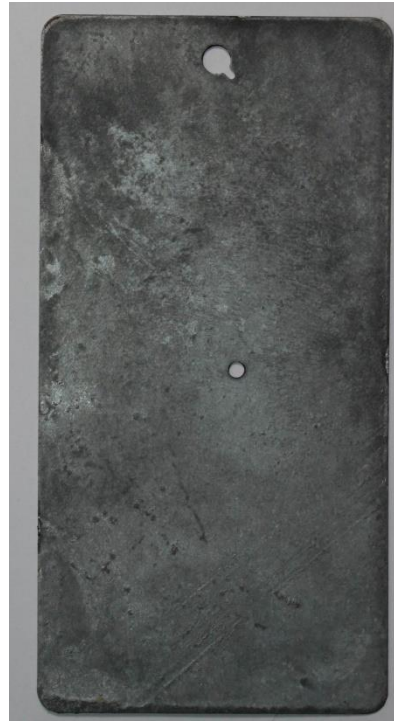
**HDG – 12 months**

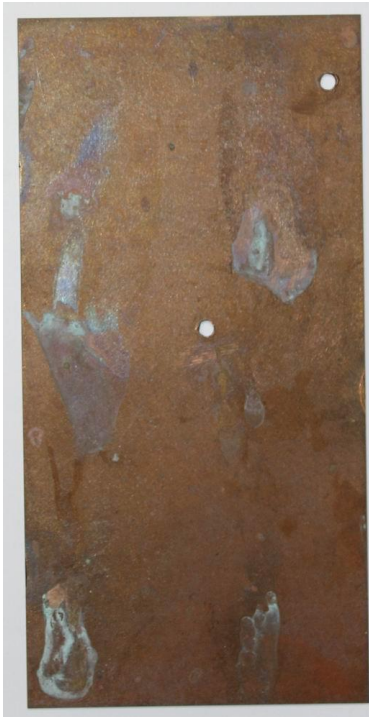
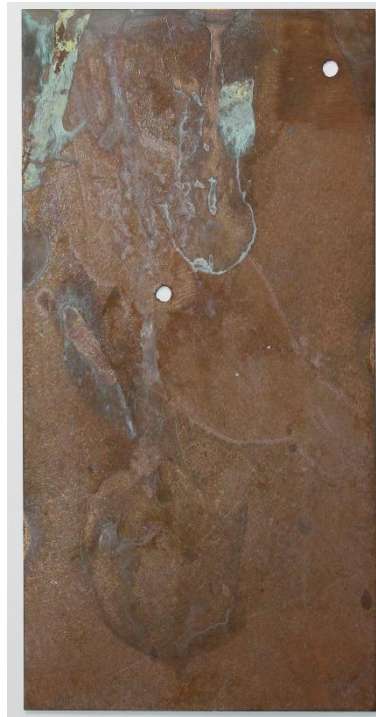
**Copper – 12 months**
