Site **OR19-10**

Dodoma OR19-10 Test Site – Atmospheric Corrosivity Mild steel - 12 months Mild steel - 12 months Mild steel – 24 months Mild steel - 24 months

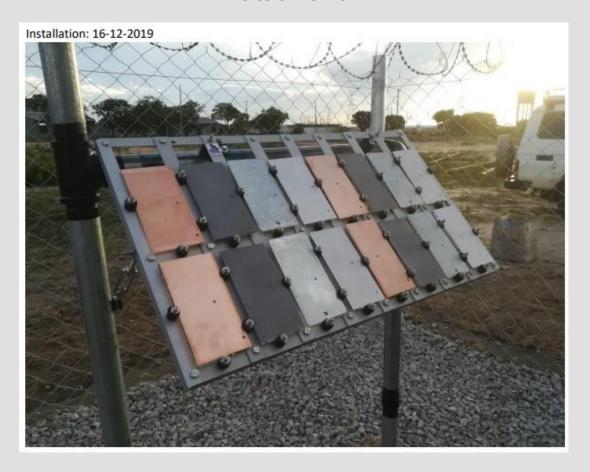
Dodoma Test Site (Image by Geosun).
