## Station Information Report

# Solar and Meteorological Station

World Bank – Homa Bay, Kenya

# Solar & Meteorological Station – Installation Report

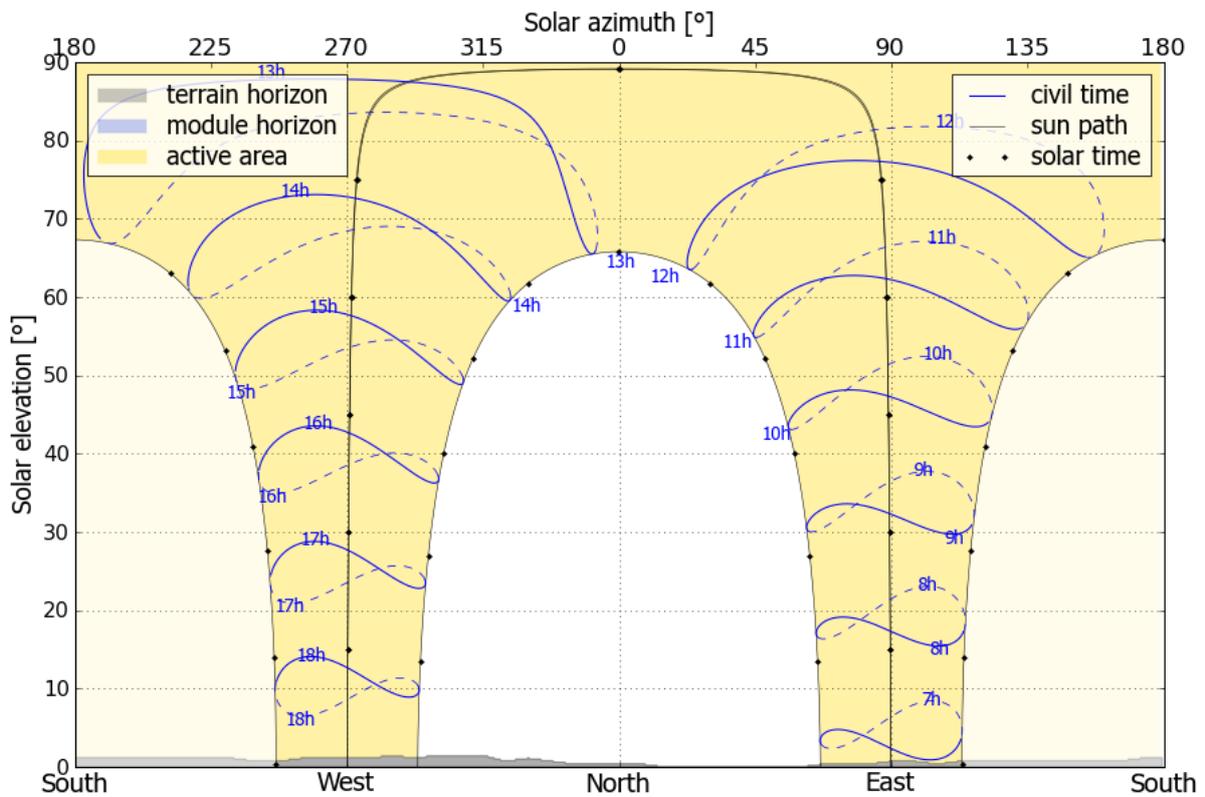
Figure 2: Terrain horizon and day length (Source: Solargis)

Obstacles protruding higher than the horizon as viewed from the solar instruments will affect lower solar elevation readings if they fall within the sun path as depicted in Figure 2. The pictures in this section shows the terrain surrounding the station at the time of installation, giving an indication of near or far shading influences on the station.

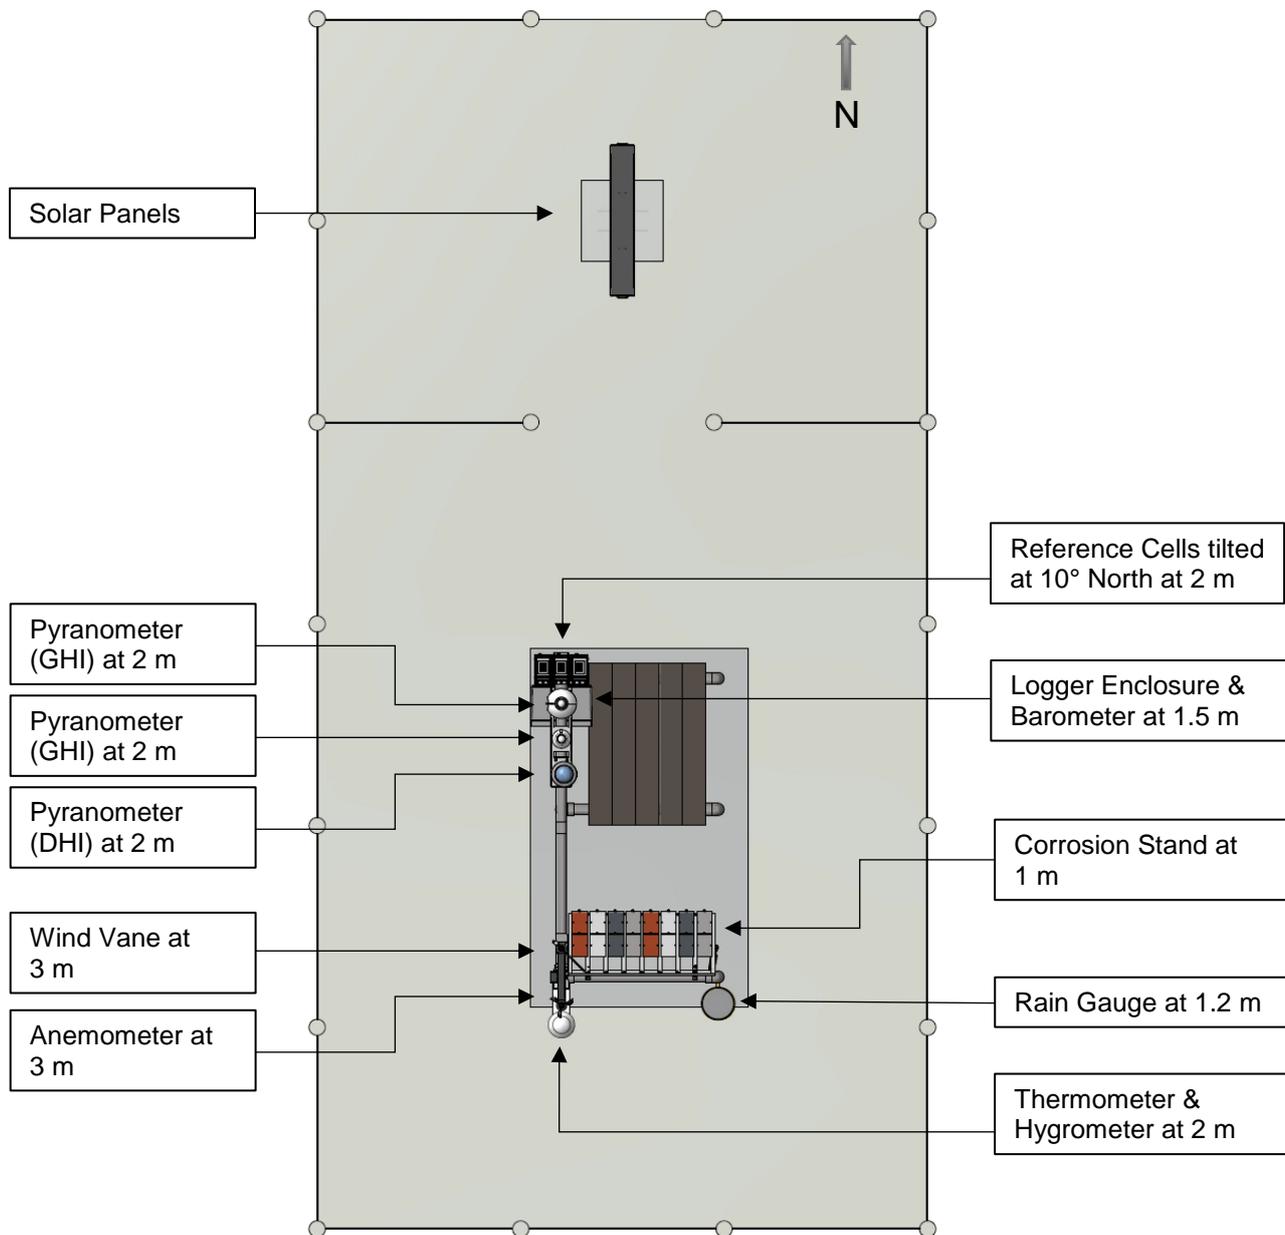
Figure 3: Site Layout (plan view)

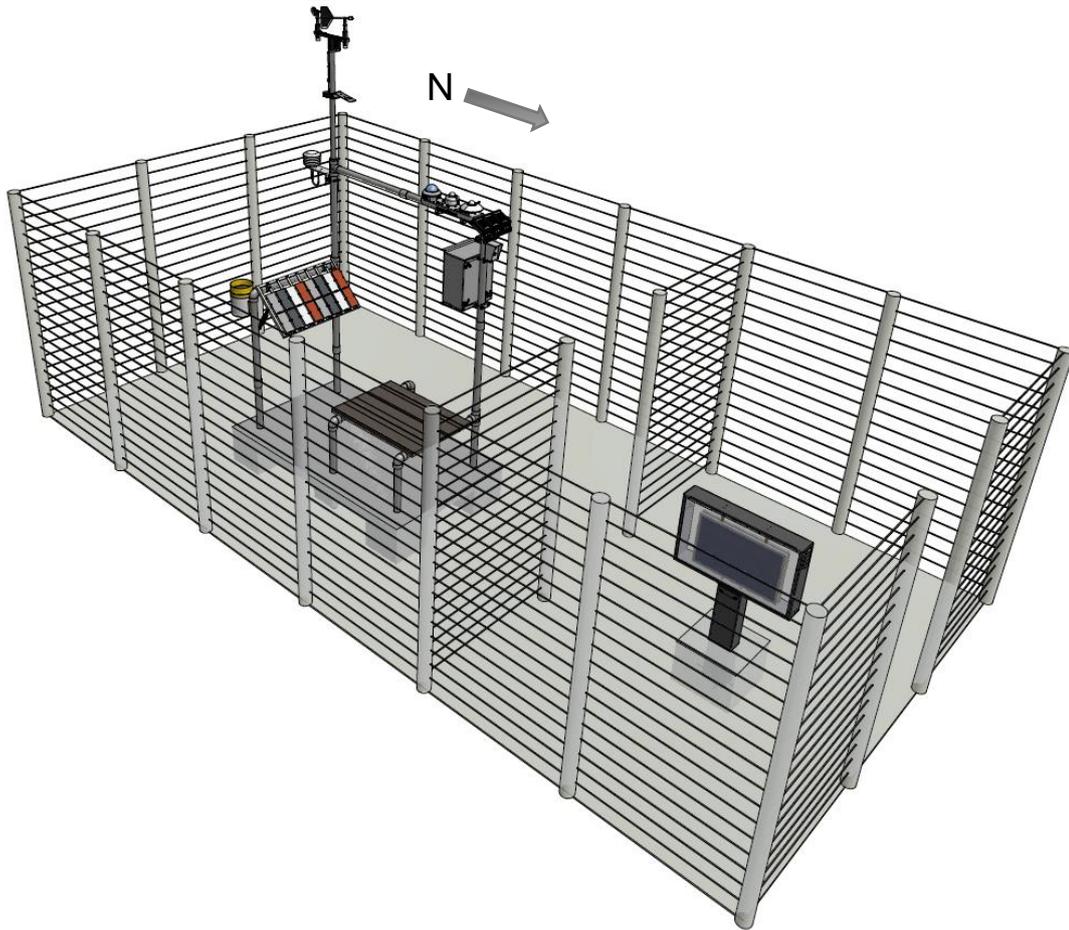
Figure 4: Site Layout (perspective view)

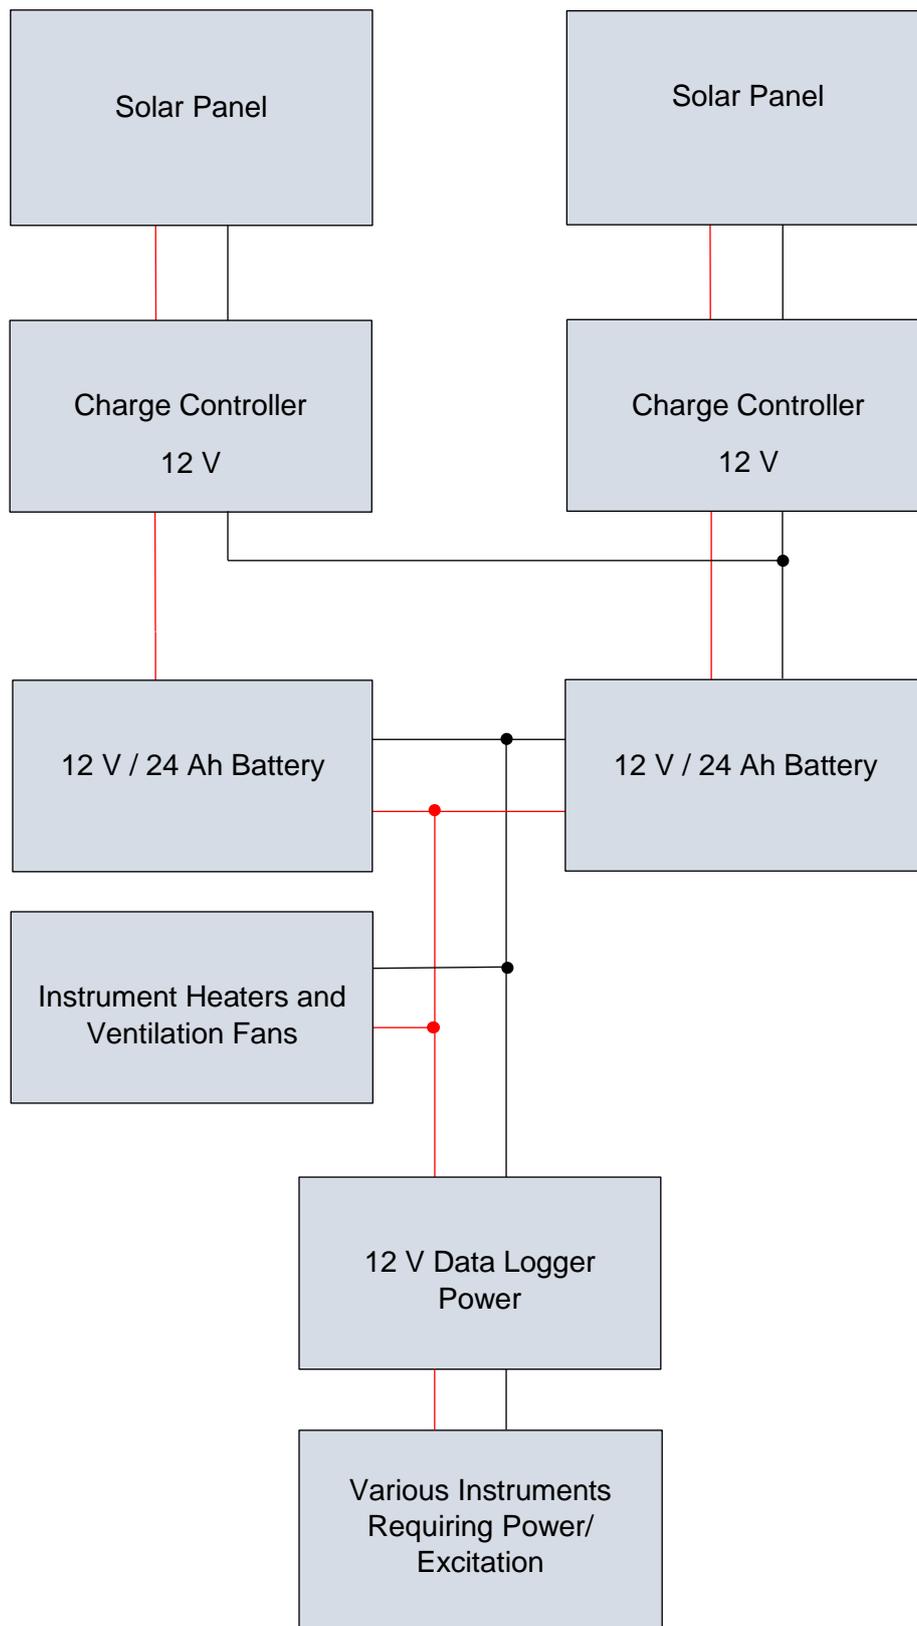
Figure 5: The DC power circuit

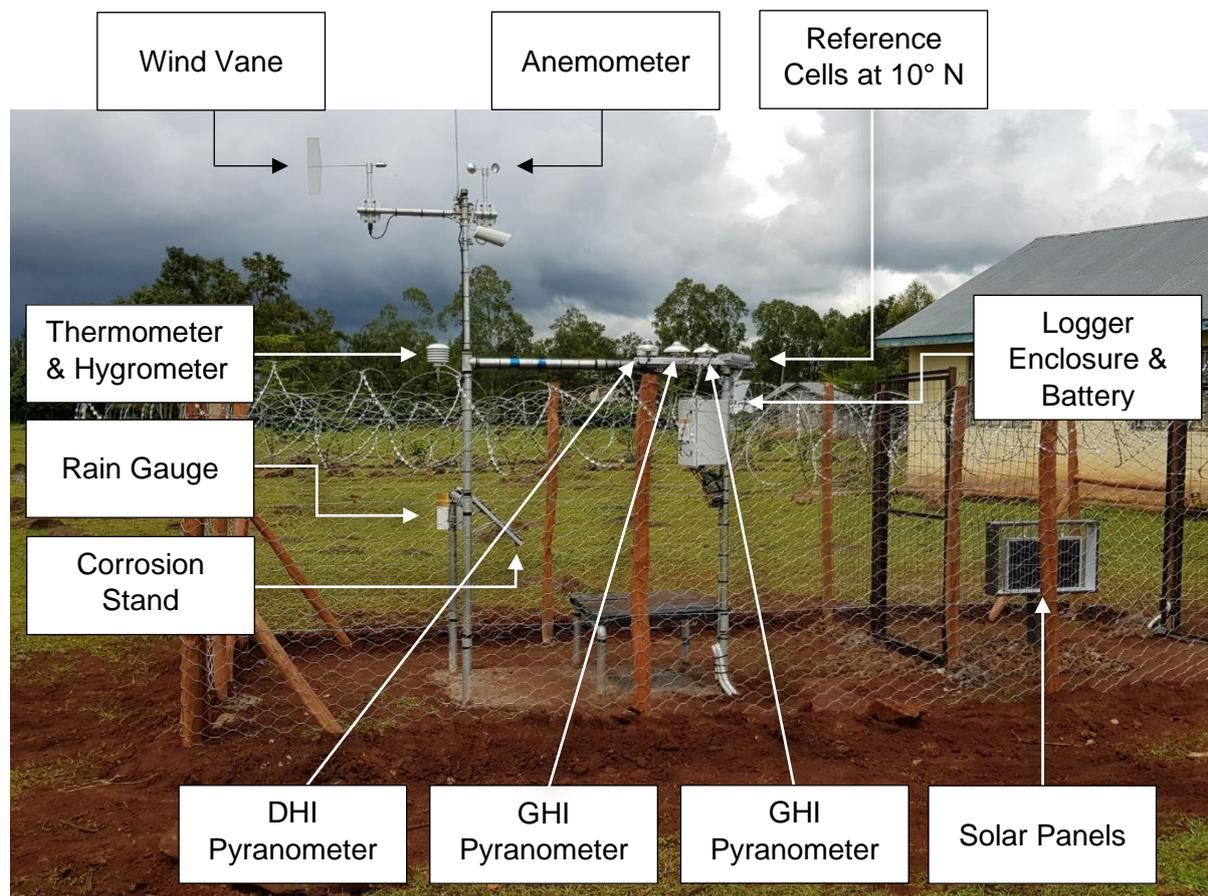
Figure 6: Station Summary

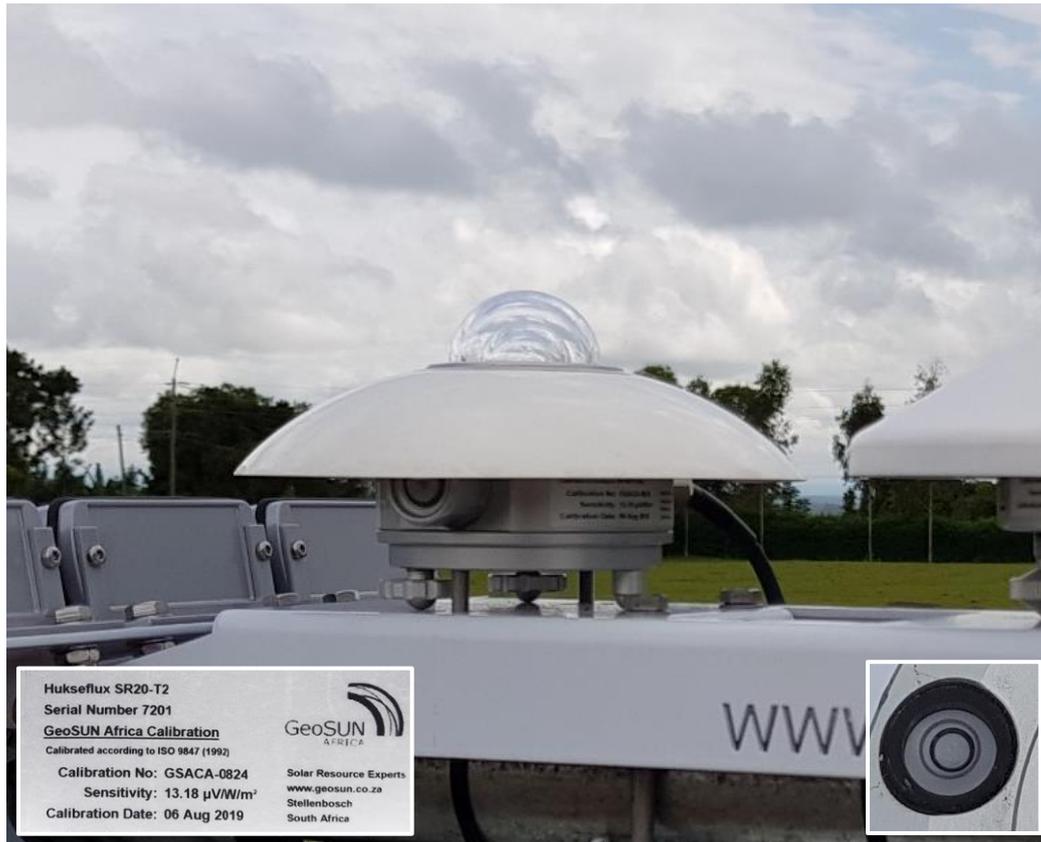
Figure 7: GHI (1) Pyranometer Installation

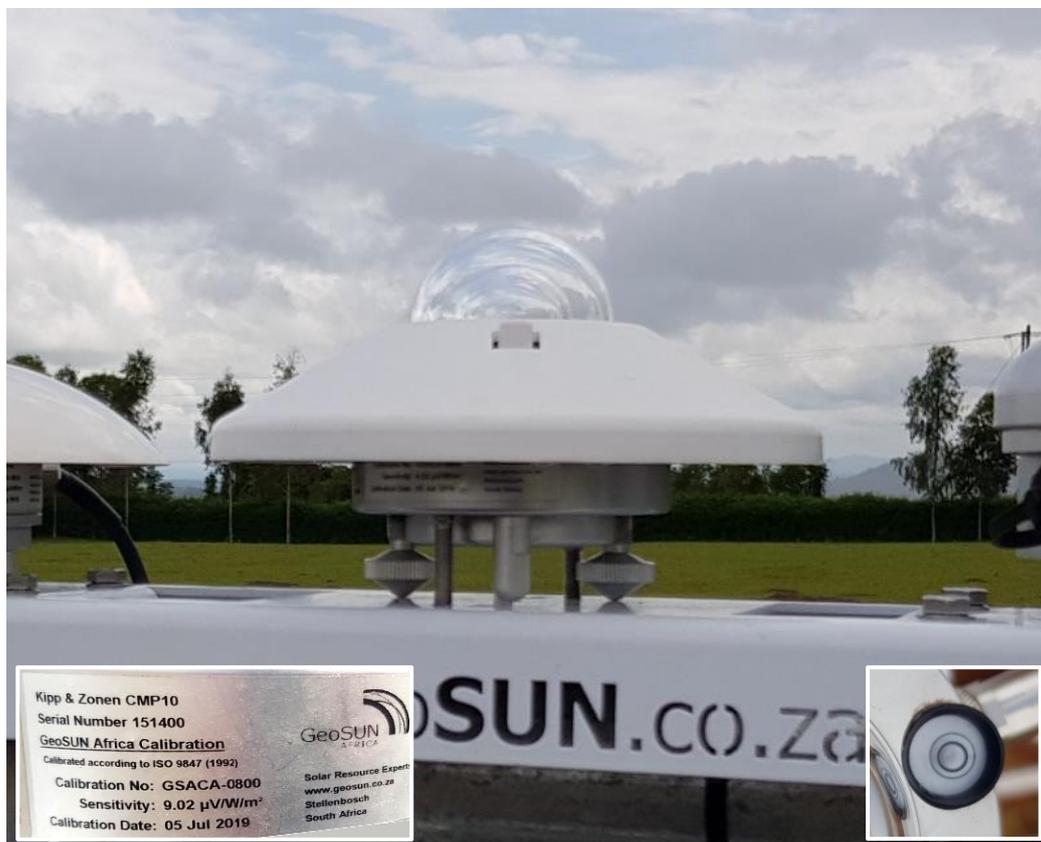
Figure 8: GHI (2) Pyranometer Installation

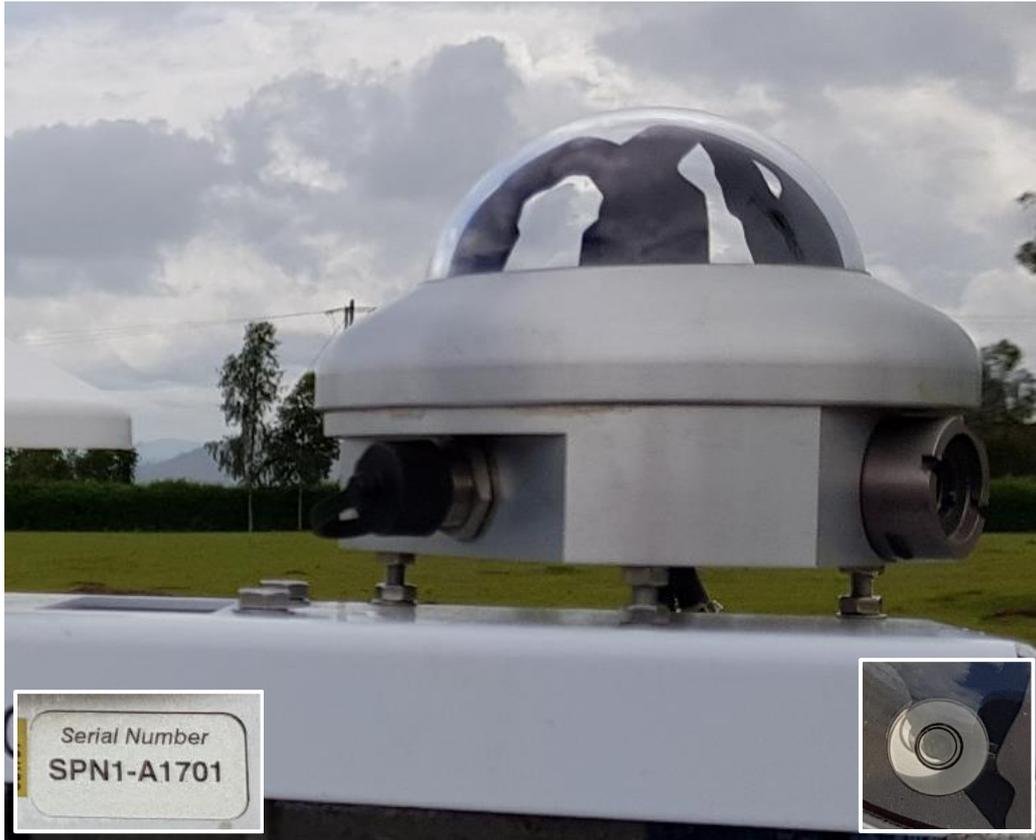
Figure 9: DHI Pyranometer Installation

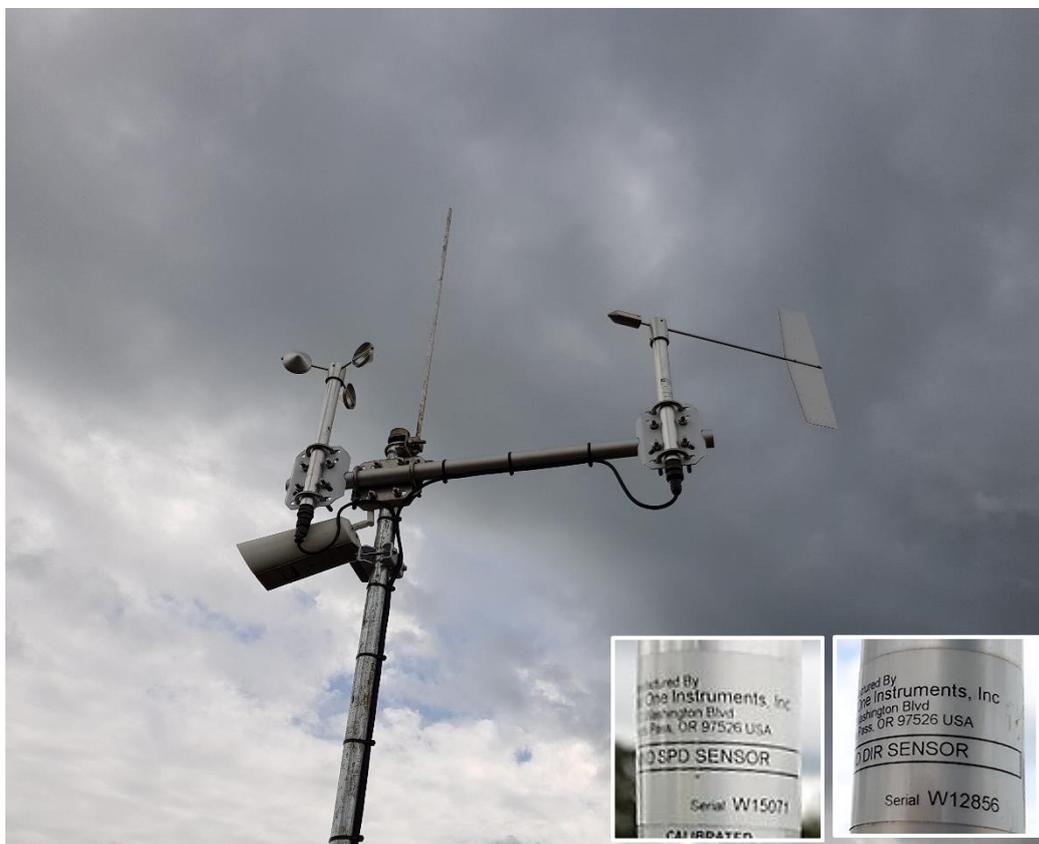
Figure 10: Wind Instruments at 3 m

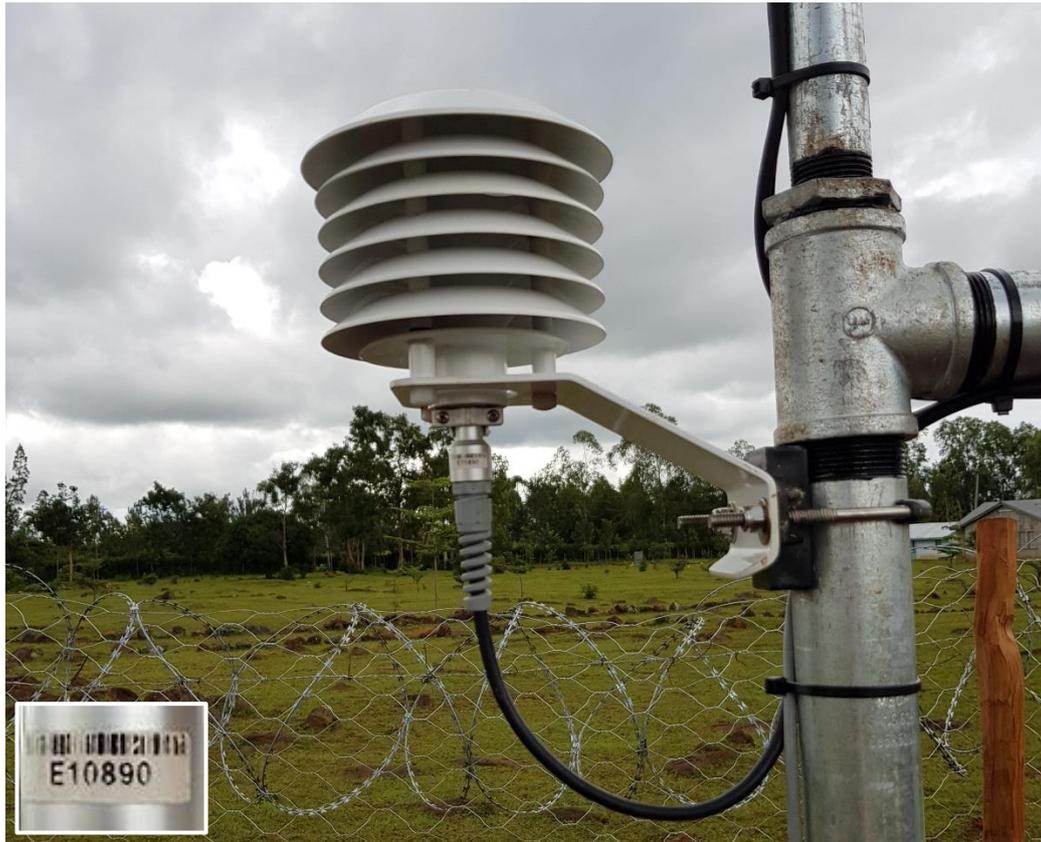
Figure 11: Thermometer and Hygrometer at 2 m

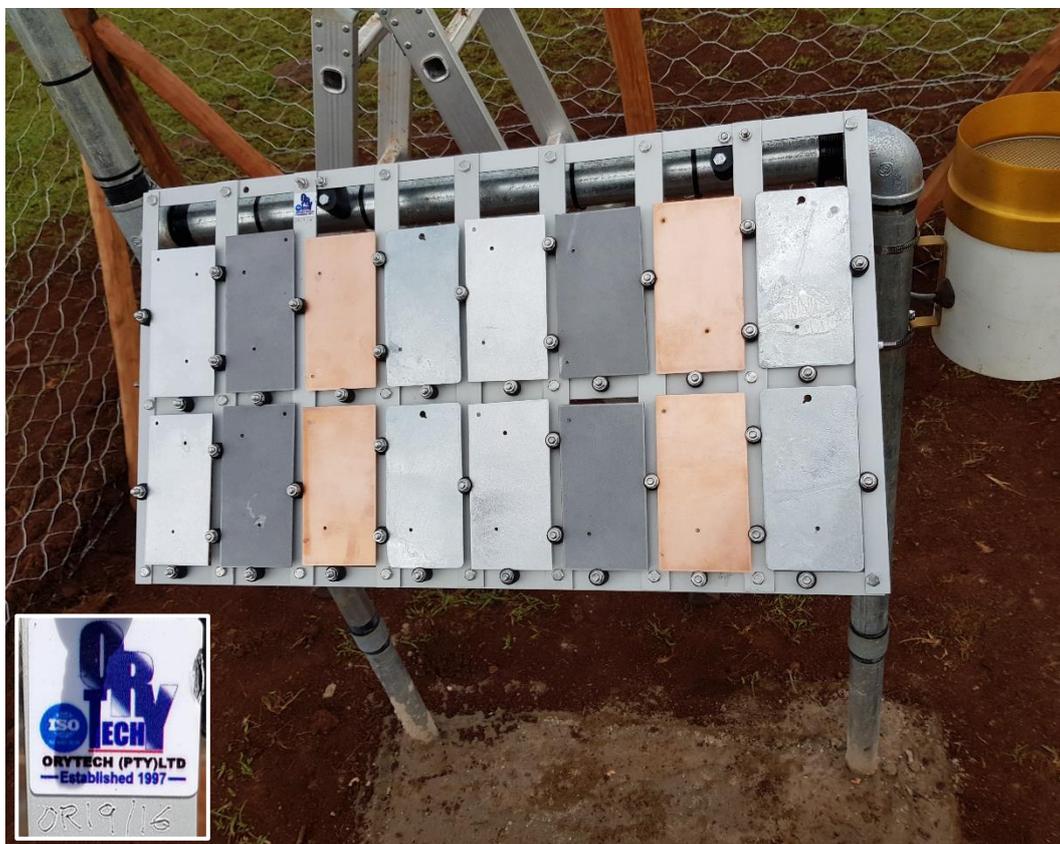
Figure 12: Corrosion Test Stand

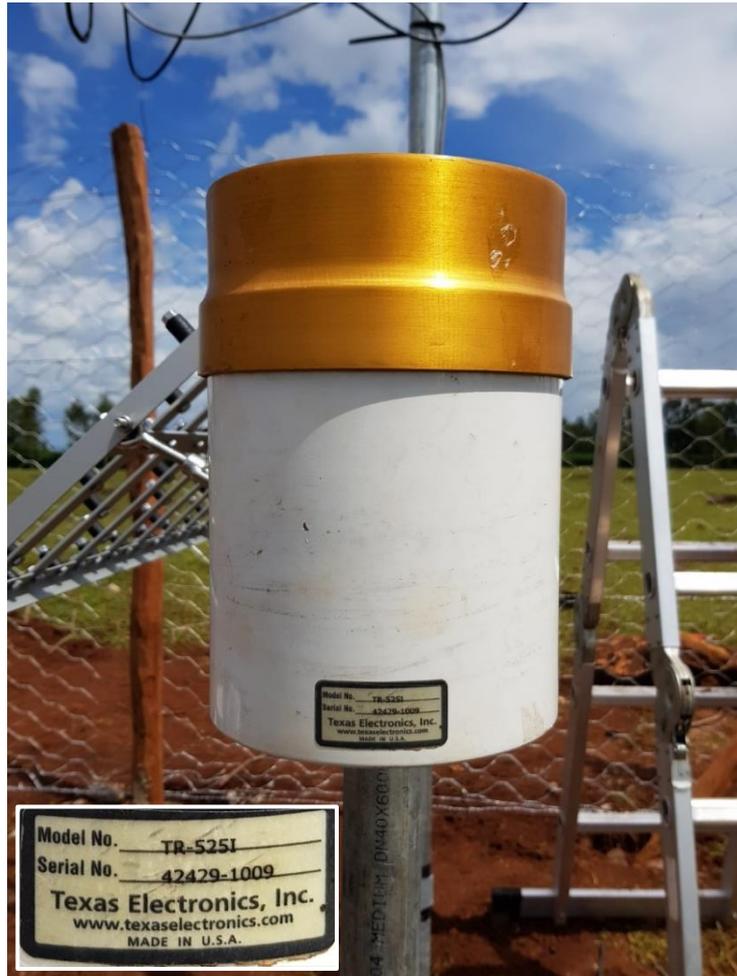
Figure 13: Rain Gauge

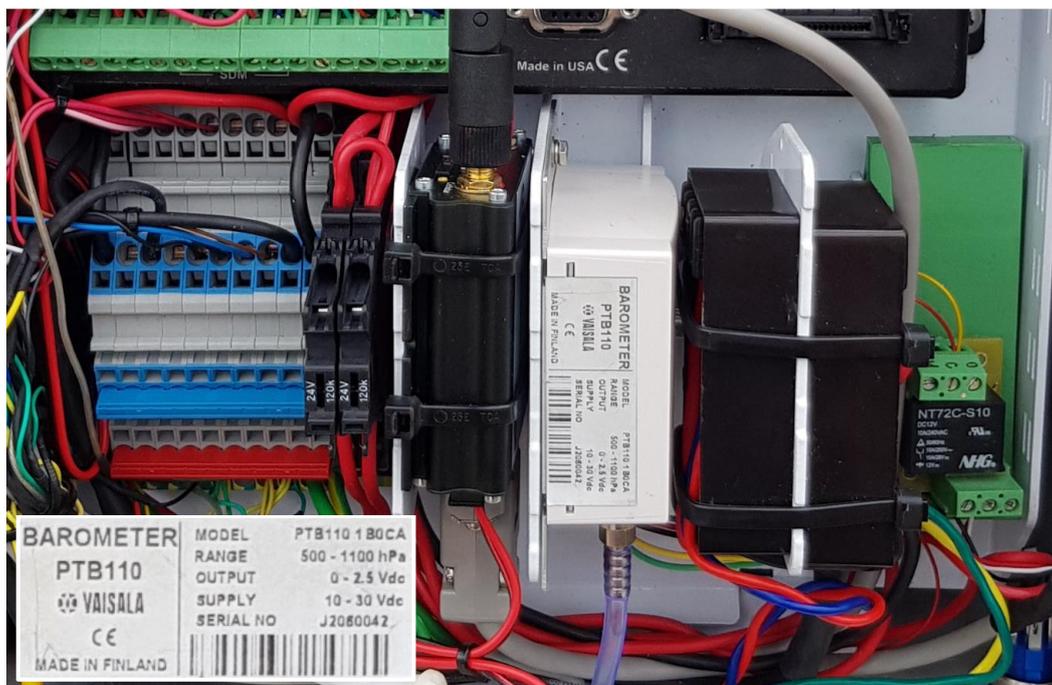
Figure 14: Barometer

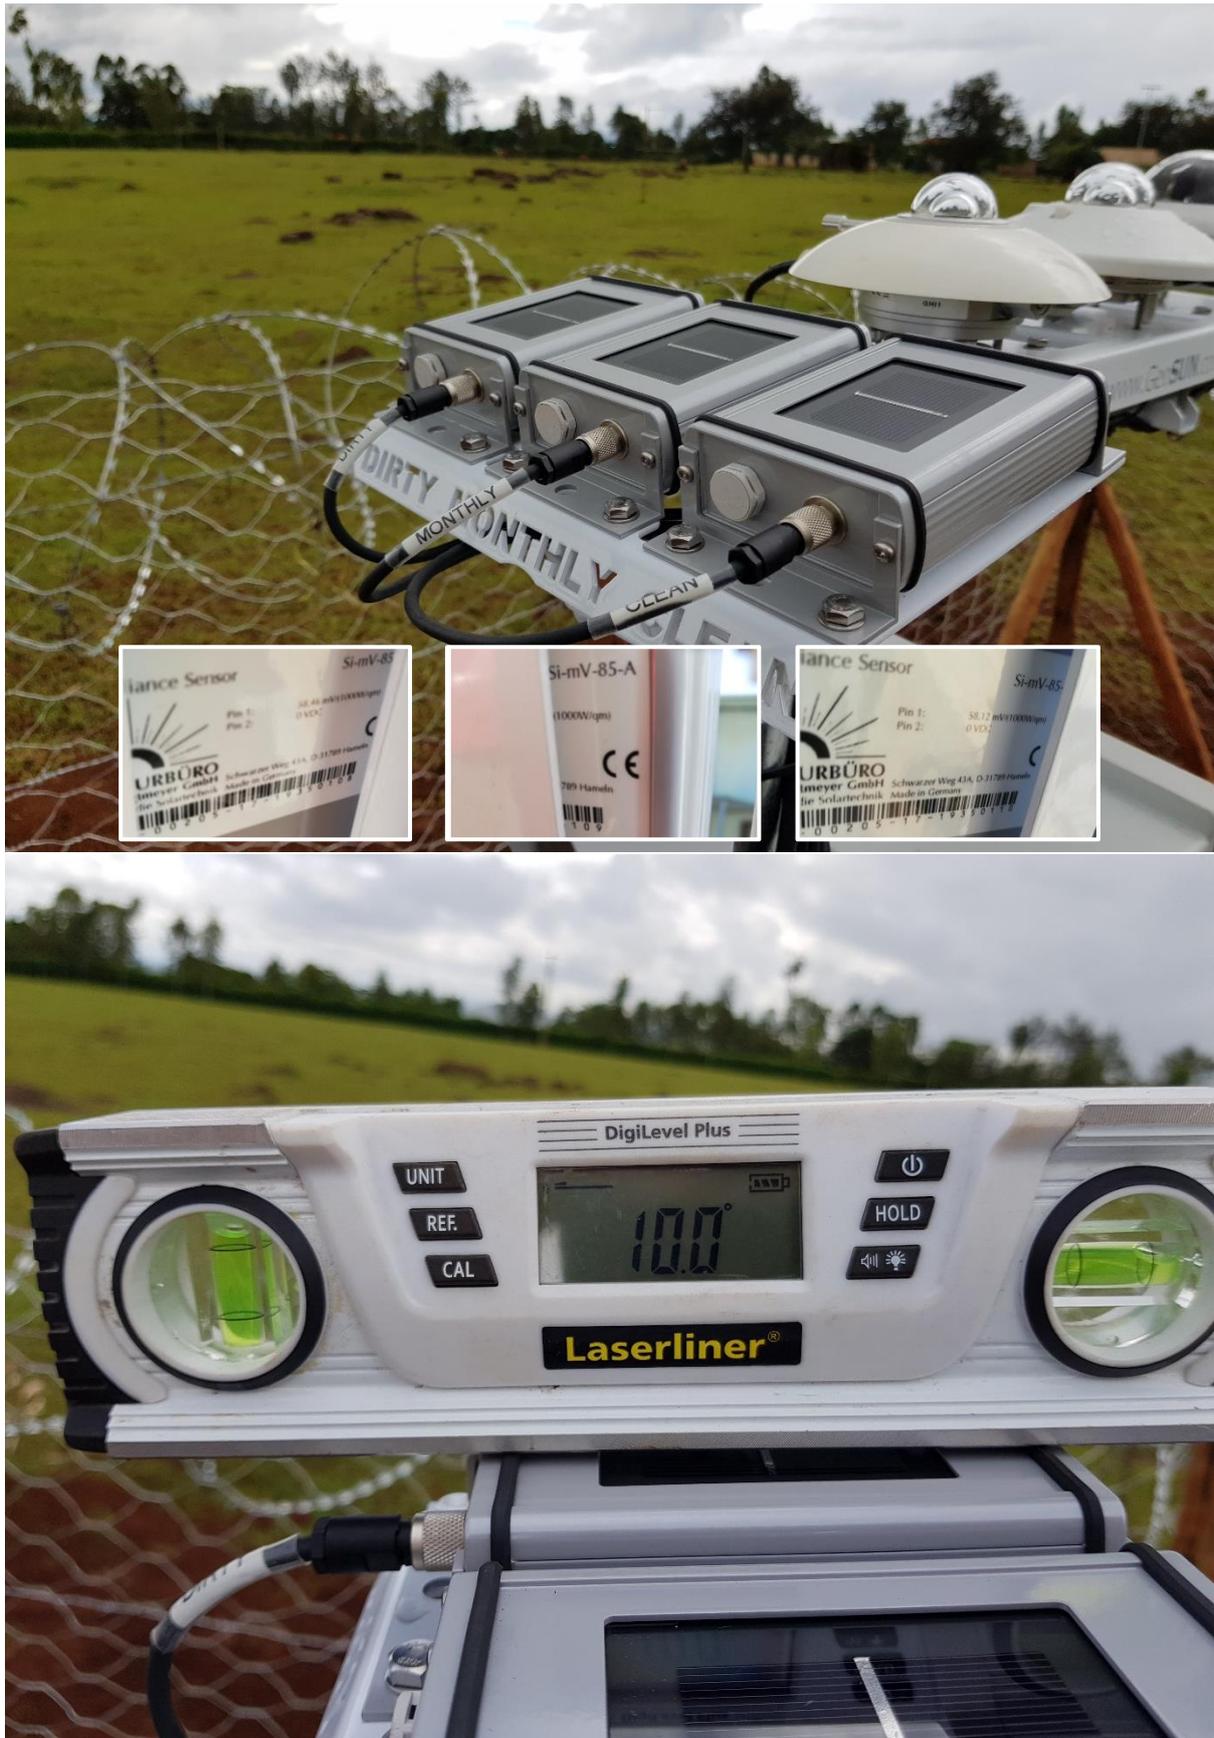
Figure 15: Reference Cells at 10° North

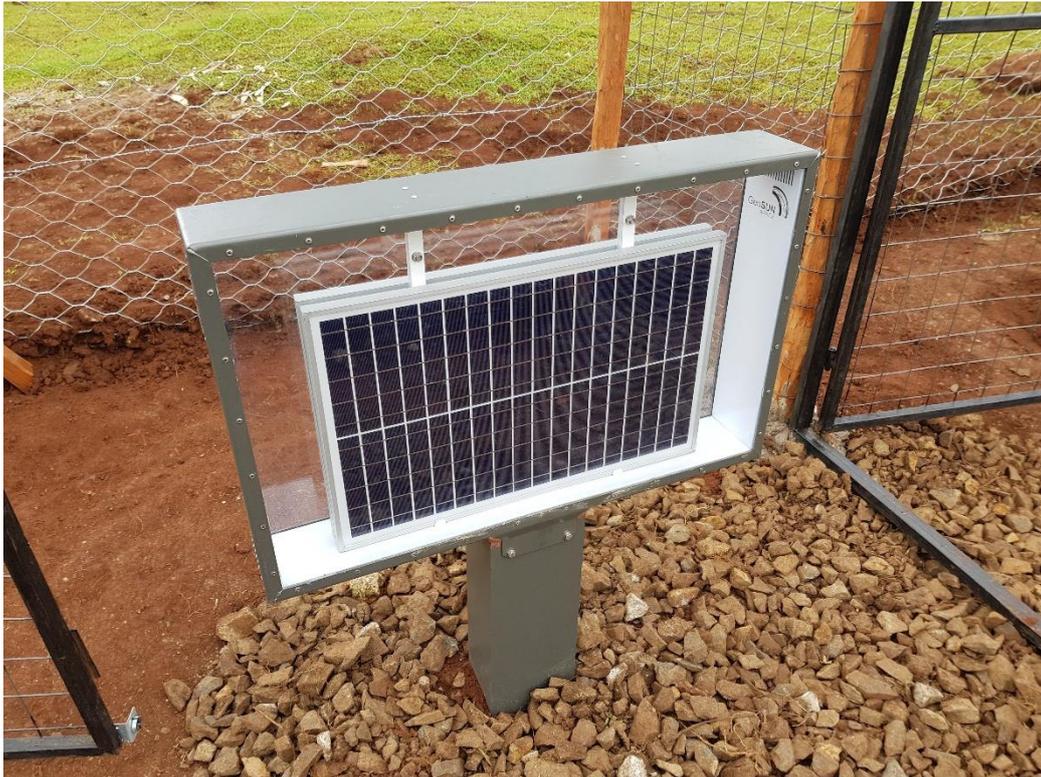
Figure 16: Solar Panel

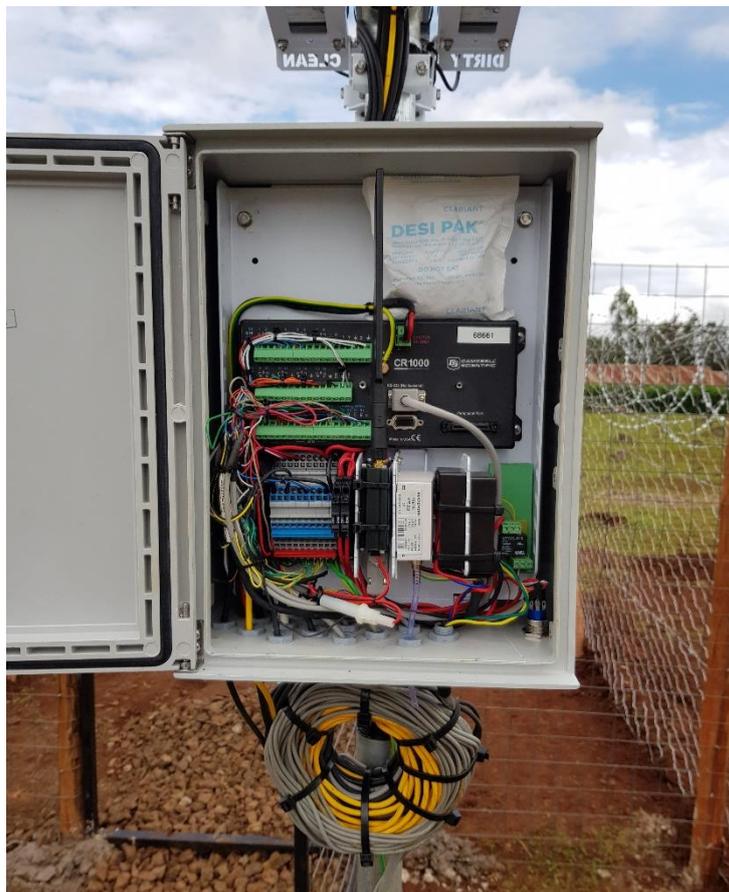
Figure 17: Logger Enclosure

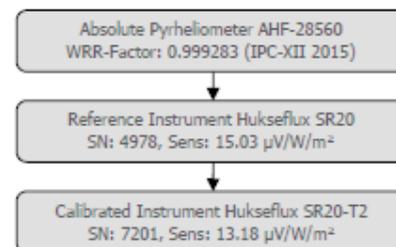
The reference instrument is a Hukseflux SR20 pyranometer (SN 4978). The instrument was calibrated on 15 August 2018 at ISO-CAL North America against absolute cavity radiometer AHF-28560 which successfully participated at IPC-XII with the World Standard Group of radiometers. The location of ISO-CAL is at 20th street, Phoenix, Arizona in the USA at latitude 33.8176944°, longitude -112.0396083° and altitude 570 m AMSL. The reference instrument was calibrated at normal incidence with the sun and sky radiation as the source using the "alternating sun-and-shade method". The readings are referenced to the World Radiometric Reference (WRR) as stated in the WMO Technical Regulations, originally with an SI relative uncertainty estimated at  $\pm 0.3\%$ . The diagram on the right shows the traceability hierarchy.

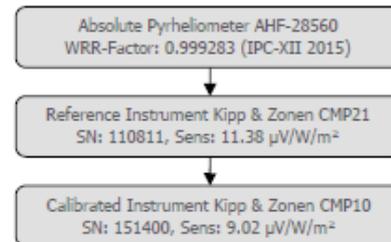
The reference instrument is a Kipp & Zonen CMP21 pyranometer (SN 110811). The instrument was calibrated on 14 August 2018 at ISO-CAL North America against absolute cavity radiometer AHF-28560 which successfully participated at IPC-XII with the World Standard Group of radiometers. The location of ISO-CAL is at 20th street, Phoenix, Arizona in the USA at latitude 33.8176944°, longitude -112.0396083° and altitude 570 m AMSL. The reference instrument was calibrated at normal incidence with the sun and sky radiation as the source using the "alternating sun-and-shade method". The readings are referenced to the World Radiometric Reference (WRR) as stated in the WMO Technical Regulations, originally with an SI relative uncertainty estimated at  $\pm 0.3\%$ . The diagram on the right shows the traceability hierarchy.
